Hydrogen failures without Hydrogen?

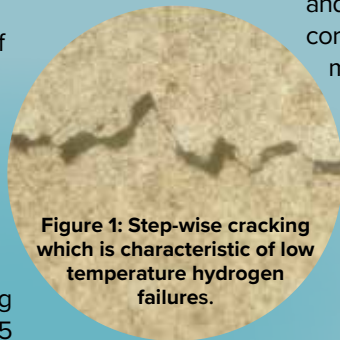
On the macro-scale, these mechanisms manifest themselves as three low temperature mechanisms (hydrogen embrittlement, hydrogen induced cracking, and hydrogen stress cracking) and are often observed in the material as step-wise cracking (Figure 1). Providing the right materials are used, hydrogen pipework / vessels generally operate without issue, however, hydrogen failures can still occur on site and pose a risk to asset integrity, often when there is no direct exposure to hydrogen.

Figure 1: Step-wise cracking which is characteristic of low temperature hydrogen failures.

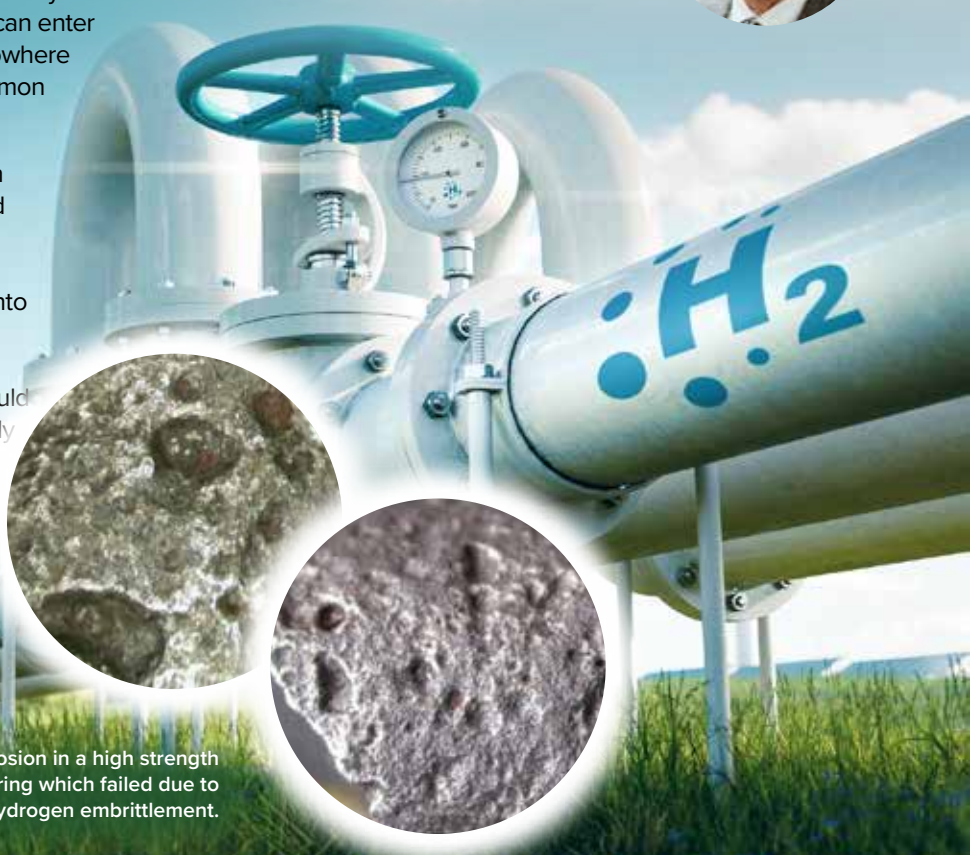
Despite regular and well documented inspection regimes for non-return valves, hydrogen induced cracking failures are still seen in high strength steel springs in these items (Figure 2). These failures occur due to corrosive product coming into contact with the bare metal of the spring, due to paint degradation typically as a result of its poor application. Failure of relief valve (RV) springs could the valve to consequently fail to lift and potentially having much larger consequences.

Figure 2: Corrosion in a high strength steel RV spring which failed due to hydrogen embrittlement.
